TOPEX/Poseidon

Satellite/Sensors Performance Characteristics Workshop #6

Presented By:
John Hultberg
Jet Propulsion Laboratory

Presented At:
JPL
July 22, 1997

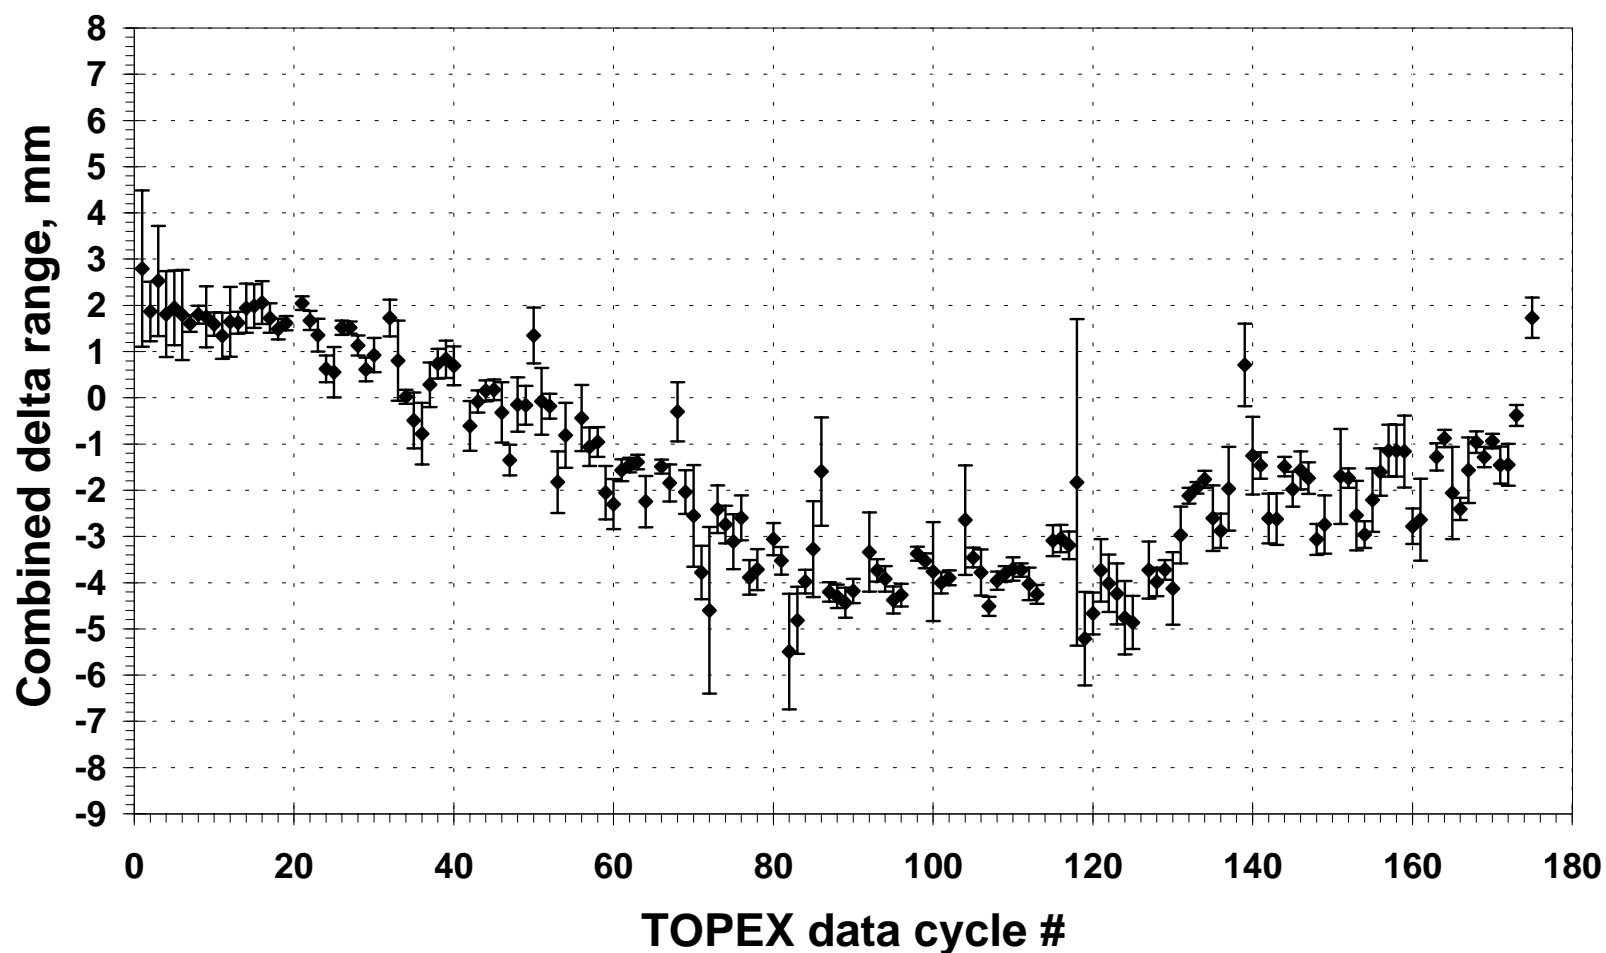
TOPEX Combined (Ku & C) Delta Range from Cal-1 Step 5 (corrected for DFB positioning quantization, but not for UCFM temperature)

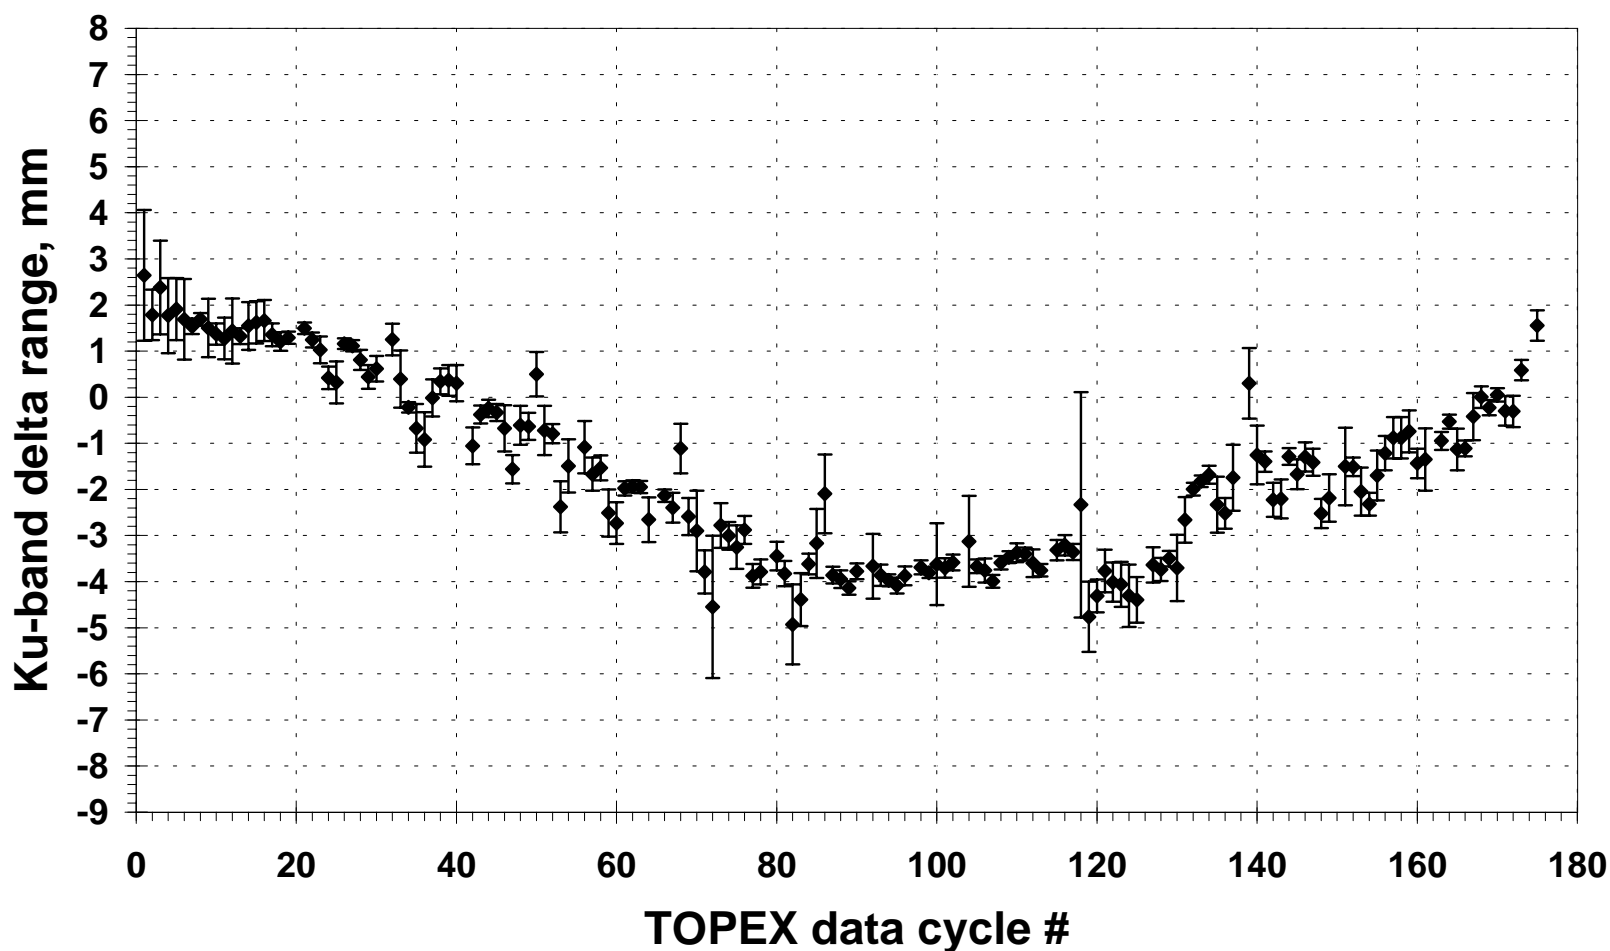
TOPEX Ku-Band Delta Range from Cal-1 Step 5 (corrected for DFB positioning quantization, but not for UCFM temperature)

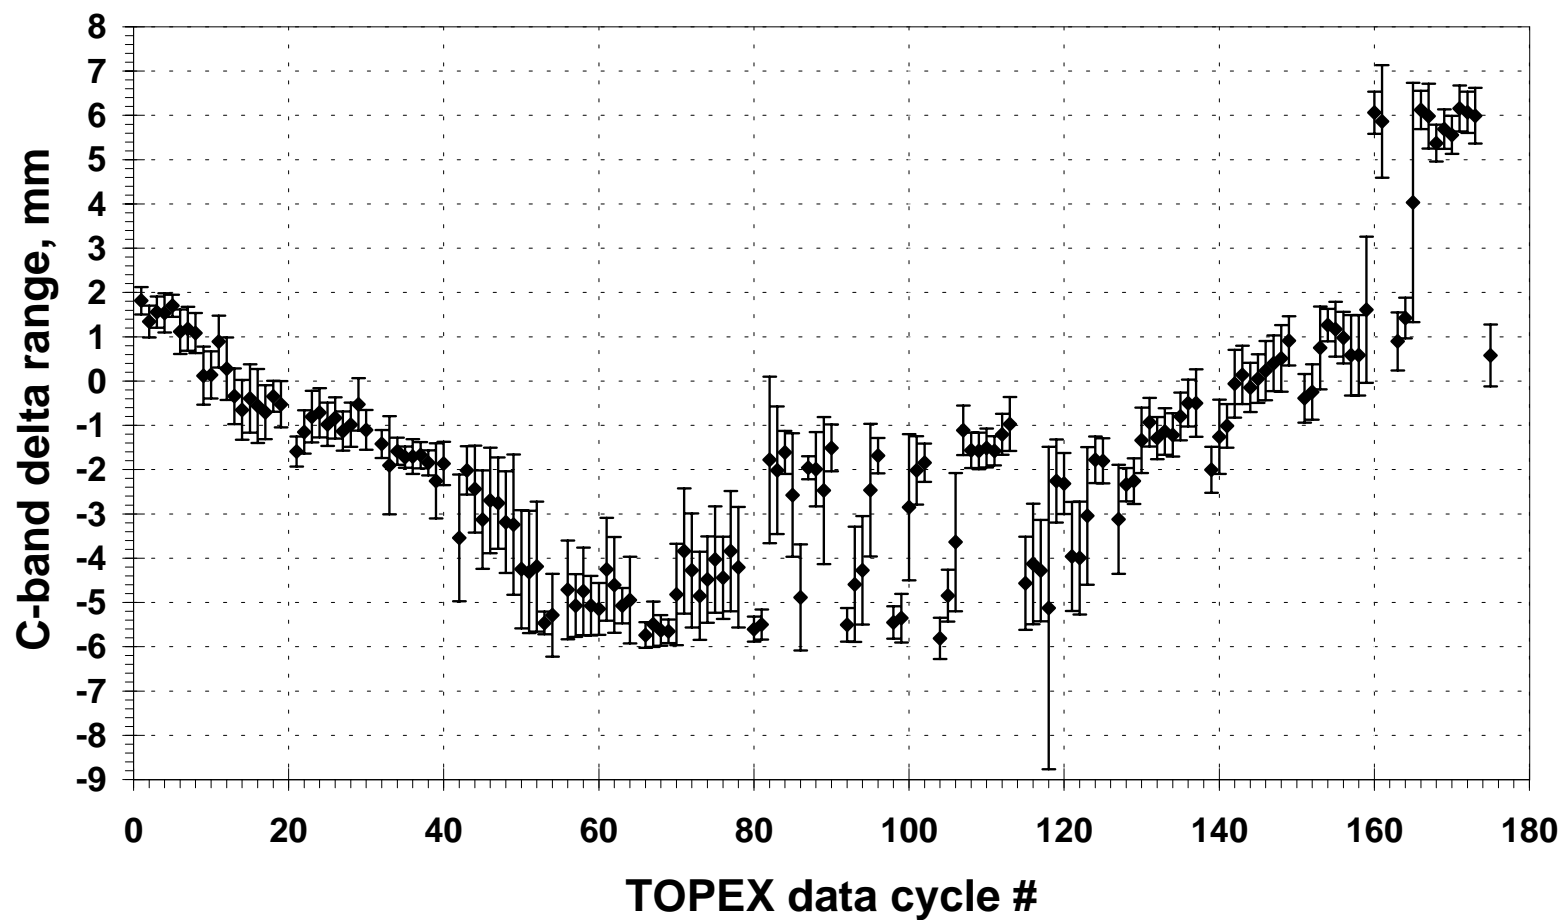
TOPEX C-Band Delta Range from Cal-1 Step 5 (corrected for DFB positioning quantization, but not for UCFM temperature)

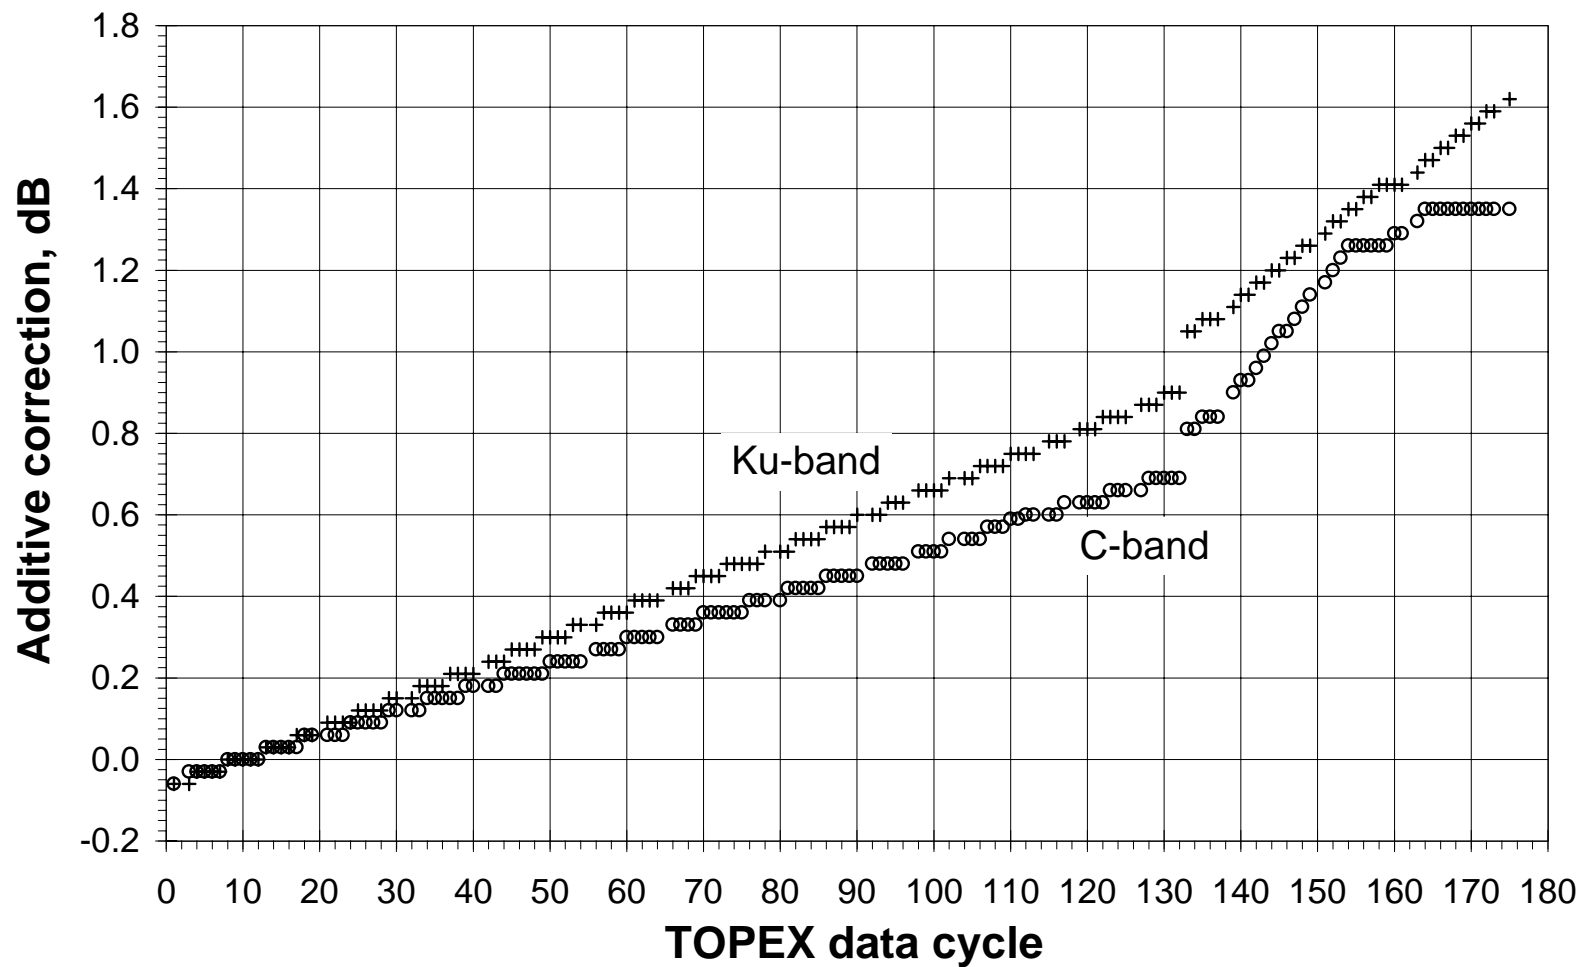
TOPEX Received Power Additive Correction
